**2011/2012 Annual Inspection
Report**

**PECAN ISLAND TERRACING
PROJECT
(ME-14)**

State Project Number ME-14
Priority Project List 7

June 13, 2012
Vermilion Parish

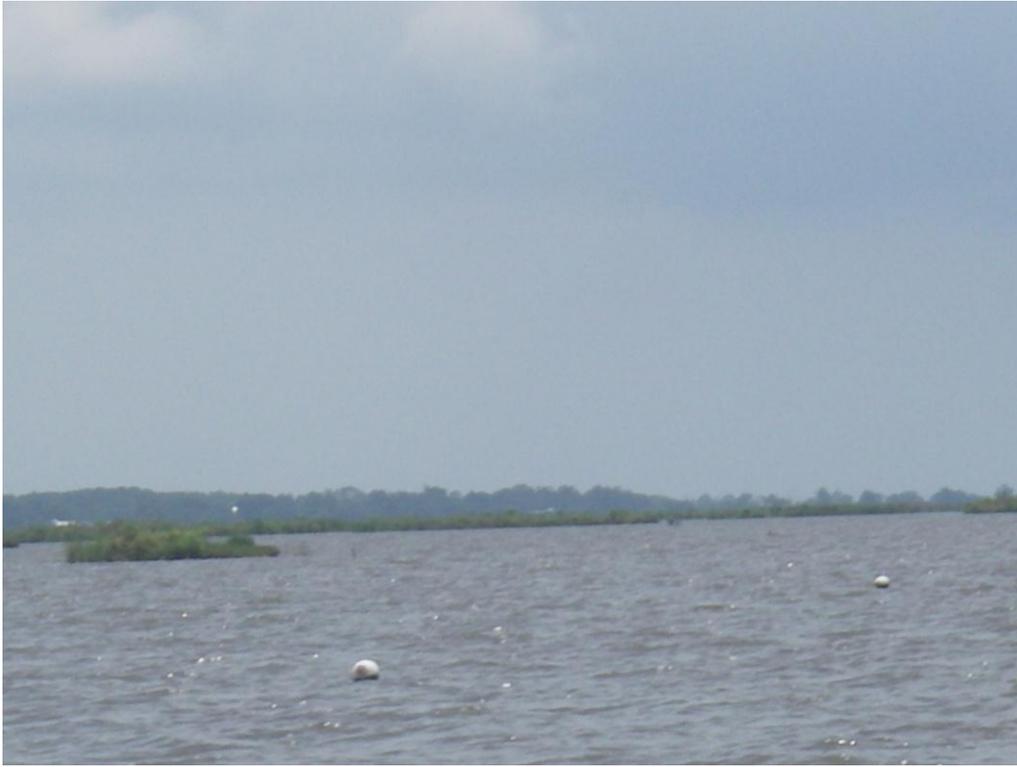
The majority of the earthen terraces are in good condition. There is some erosion taking place on the north side of the individual terraces. Previously noted erosion on the southernmost sacrificial terraces has worsened. On the west side of the terrace field, the first two rows of the southernmost sacrificial terraces are no longer visible above the water surface. The third row is also beginning to show signs of degradation. In addition, a portion of the first row of the east southernmost terraces is no longer visible above the water surface. (Photos: Appendix B, Photo 1)

Photo No. 1, Southernmost Earthen Terraces Showing Erosion

Overall, the Pecan Island Terracing Project (ME-14) is functioning as designed and in good condition. The erosion of the southern sacrificial terraces will continue to be monitored. NOAA and CPRA have agreed to investigate land rights and possible erosion solutions for these sacrificial terraces. If feasible, an additional request for funding will be needed for this maintenance event.

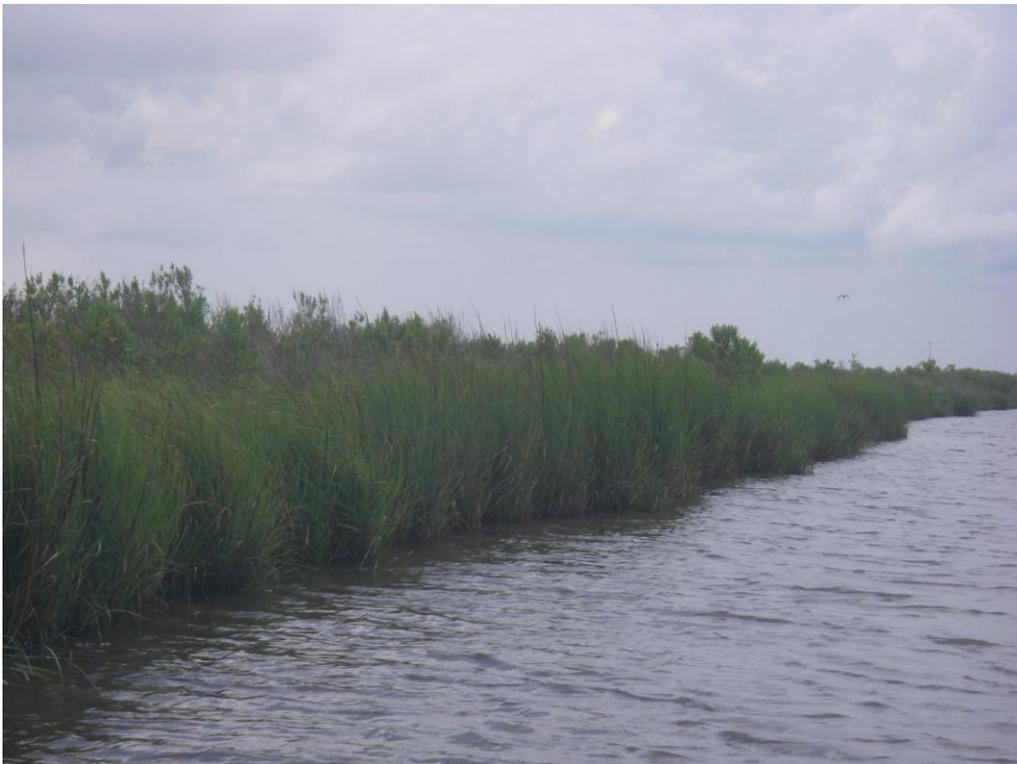
The tops of the terraces are covered with vegetation. Species noted include *Spartina alterniflora*, *Baccharis*, and *Spartina patens*. (Photos: Appendix B, Photo 2)

Photo No. 2, Typical Terrace, Showing South Side of Individual Terraces

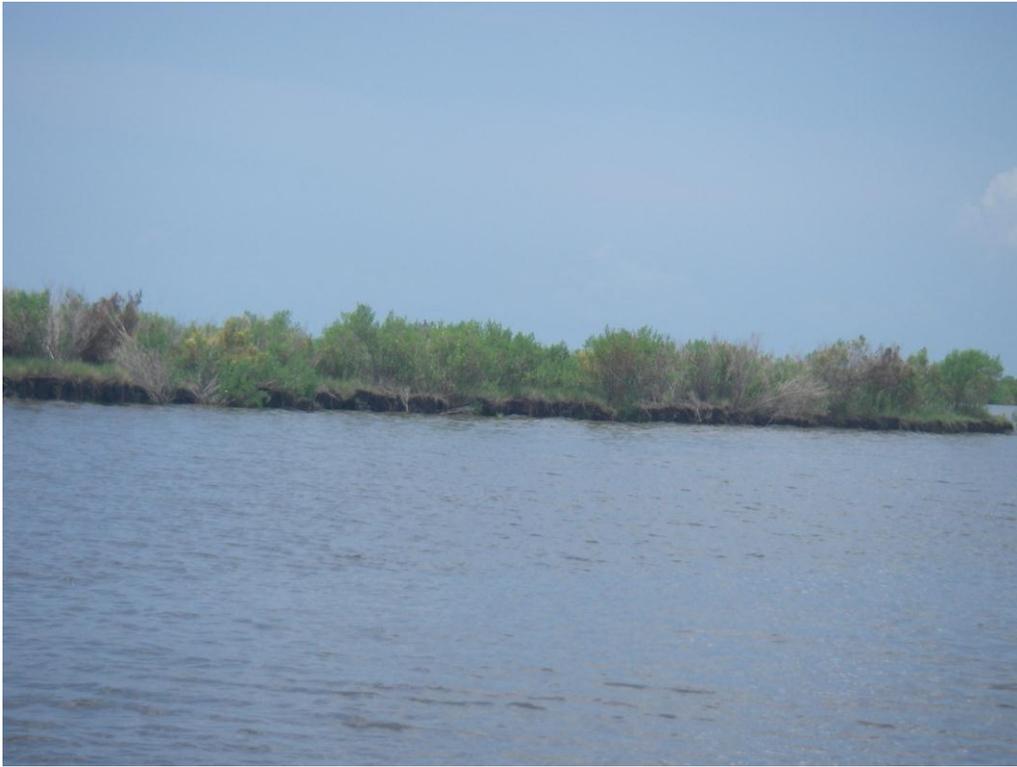
Photo No. 3, Typical Terrace, Showing Erosion on North Side of Individual Terraces
